# Alachua County Civil Courthouse

RE: Green Globes® CIEB Third-Party Assessment of the ***Alachua County Civil Courthouse***, located at ***201 East University Avenue, Gainesville, FL. 32601.***

Thank you for the opportunity to complete a Green Globes® for Continual Improvement of Existing Buildings (CIEB) assessment of ***Alachua County Civil Courthouse.***

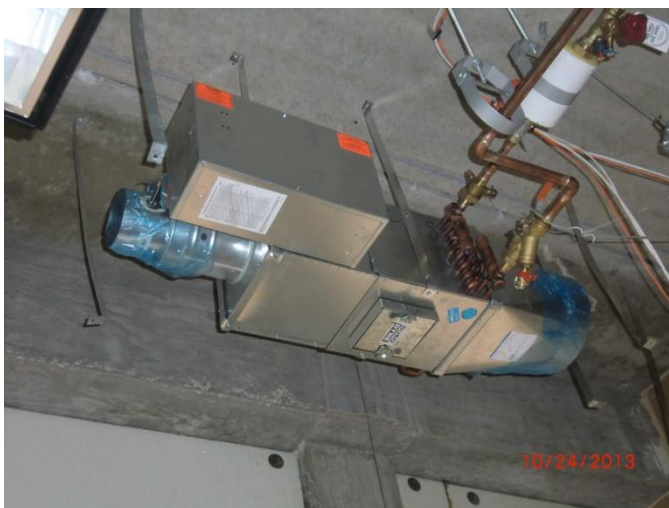
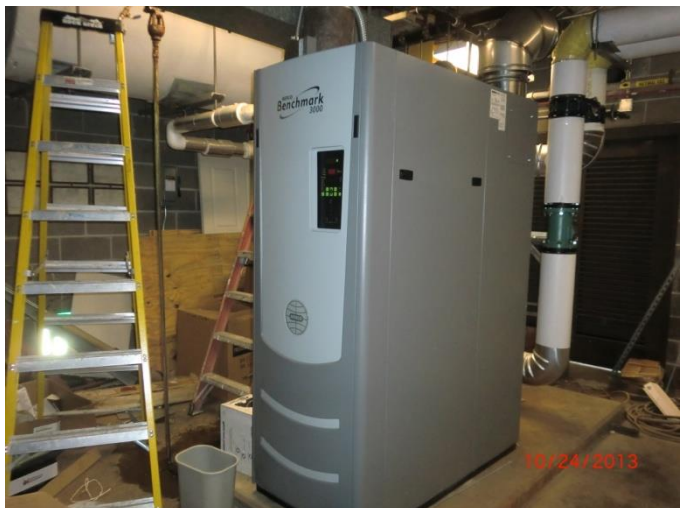
- The Alachua County Civil Courthouse building is currently in the midst of a significant HVAC renovation project which encompasses the following scope:

- o Interior spaces re-zoned for greater finite thermal comfort control
  - o Replacement and/or cleaning and sealing of all duct including outside air ducts

- o Replacement of chilled water piping where necessary
  - o Installation of 13 new direct drive air handling units (includes a retro-fit for an additional 2 units)

- o System has been changed from constant volume to variable volume with terminal reheat
  - o Installation of a highly efficient sealed combustion boiler with a VFD on the blower

- o Installation of new chilled water and hot water (boiler) pumps
  - o Migration from pneumatic to digital (BAS) controls
  - o Addition of new thermostats throughout the building

- As part of this renovation project, lamps are being changed to T-8's.
- A separate refurbishment project accomplished in June 2012 involved a detailed assessment and subsequent waterproofing/sealing of the building envelope.

1. Given the aged condition of the two domestic hot water heaters serving the building, consider replacing with either condensing water heaters for storage of large quantities of water or tankless (instantaneous) hot water heaters where the demand for hot water is occasional rather than continuous, and the volume required is relatively low. Solar water heating can also be effective where there in areas with sufficient solar access.

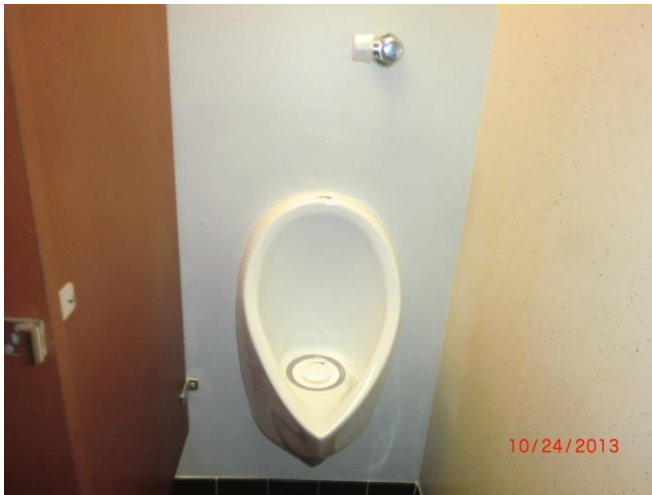
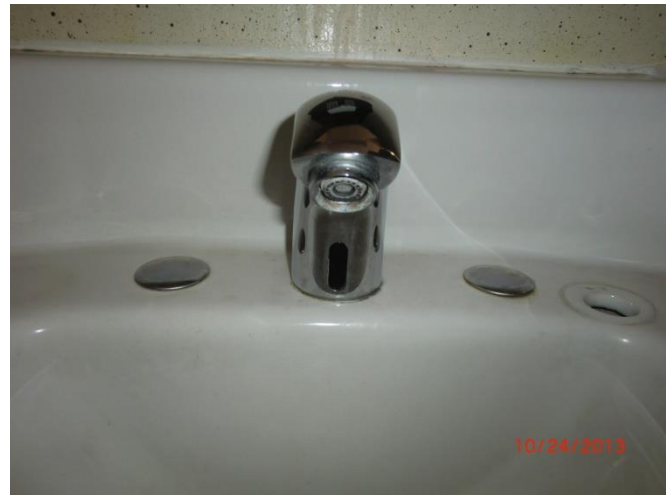
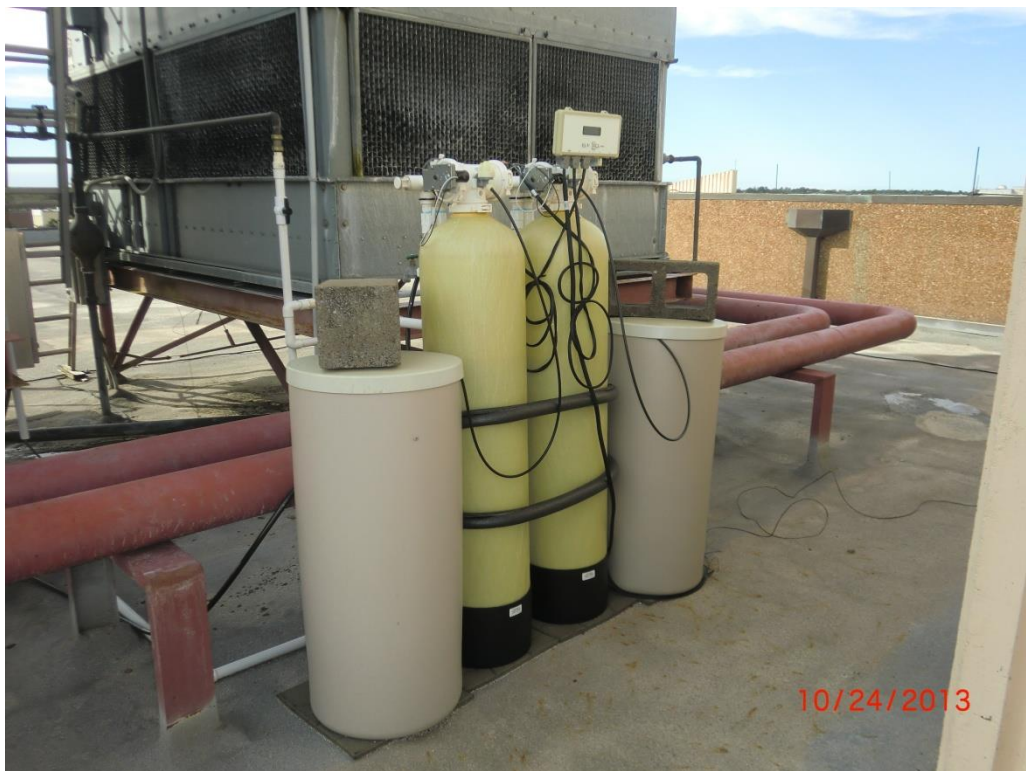
- In 2009 flush fixtures were replaced with dual-flush toilets and waterless urinals.
- Proximity detectors were observed on most faucets.
- The site does not require irrigation.
- A ZeroTek high cycles cooling tower water saving device has recently been installed. Manufacturer data claims an annual water savings of 59%.
- An extensive Alachua County Water Conservation Initiative was prepared by the Environmental Protection Department Staff in April 2010 and includes best practices and "next" practices opportunities.
- Alachua County's Facilities Management Division observes an annual Energy & Water Conservation Day.
- ***Building scored 68 out of a possible 74 for 92% of the available points.***

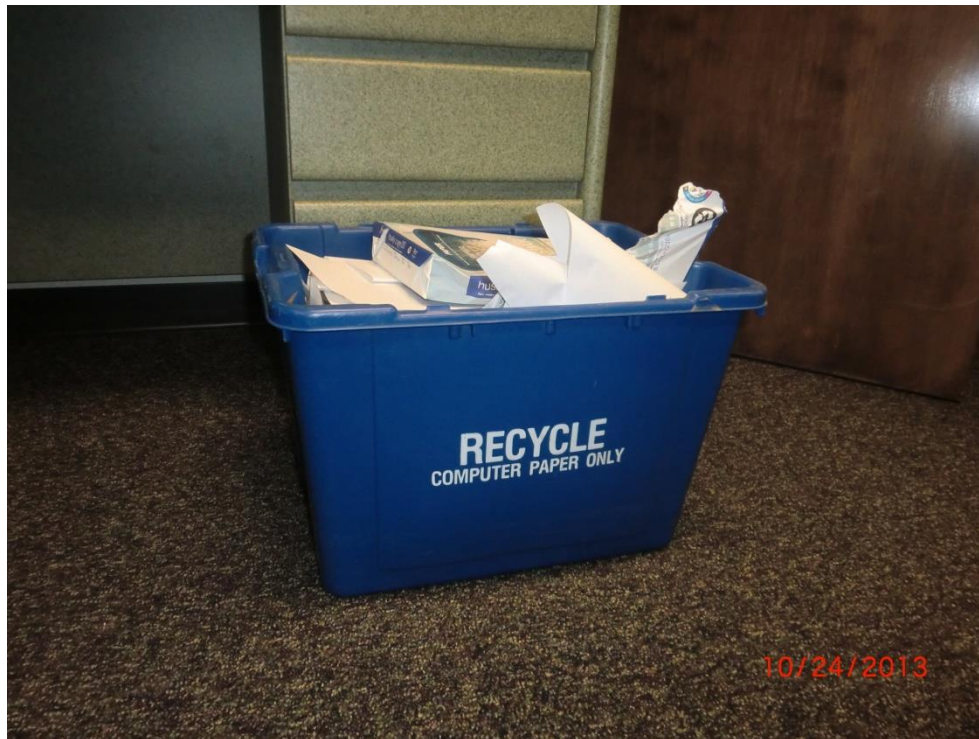
- Collection points for recyclable waste are located on each floor with blue boxes scattered throughout most of the open office areas.
- A third-party collection firm, Commercial Metal Company, has been hired to collect all duct and copper generated as a result of tear-out and renovation activities.
- Neither waste reduction targets nor a comprehensive waste reduction plan have been established for this facility.
- ***Building scored 70 out of a possible 105 for 67% of the available points.***

1. Currently waste generated by this facility is not monitored, tracked or targeted for improvement. As a result there is tremendous opportunity for Alachua County Facilities to demonstrate a further commitment towards maintaining sustainable built environments by engaging in a waste audit to determine suitable avenues for the diversion of waste streams from landfill sites.

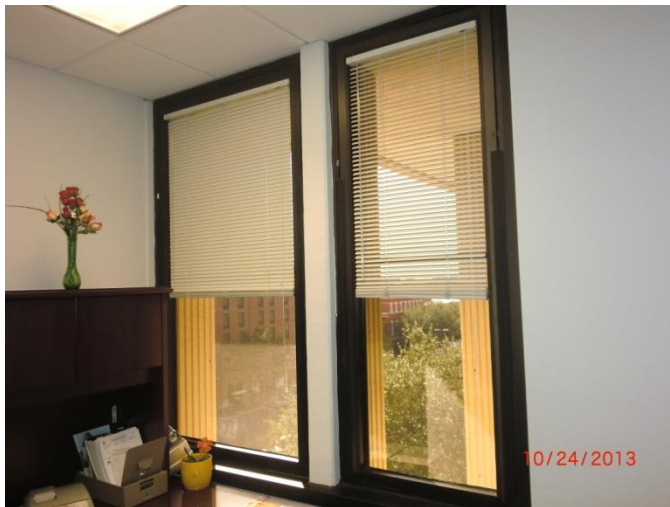
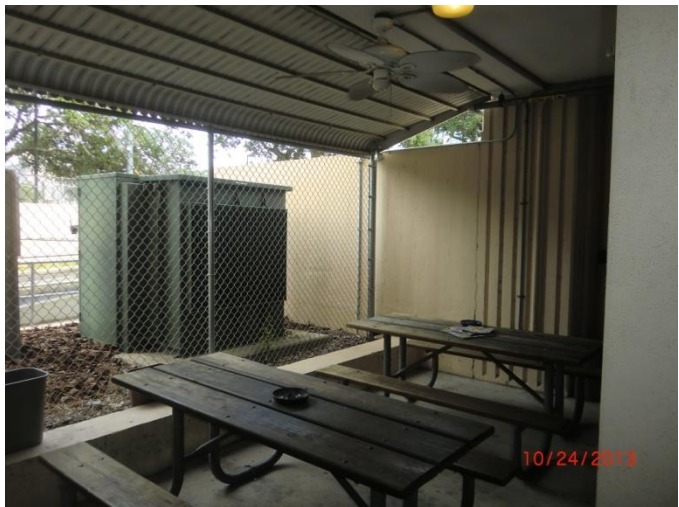
- MERV 13 filtration media is used in all new air handling units.
- A designated smoking area located outside the building was observed to be sufficiently distanced from all entryways.

- Office space temperatures are controlled by wall-mounted, digital thermostats
- Task lighting has been provided for the majority of all workstations.
- Controllable internal blinds were observed in the majority of office areas with fenestration. Additionally, solar screens have been installed on the east, west and south exterior facades.

- Housekeeping procedures include a planned schedule for the cleaning of light fixtures.
- Given the confidential nature of activity conducted inside this facility, exceptional sound attenuation measures have been implemented, most especially for critical spaces such as the Judge's Quarters and Grand Jury Room.

1. At the conclusion of renovation activities, measurement of CO<sub>2</sub> levels in regularly occupied spaces may inform building operations staff in the fine-tuning of outdoor air delivery sequences. Furthermore, demand-controlled ventilation strategies may be considered for spaces that experience high occupancy for minimal time durations i.e. conference rooms.
